TECHNICAL ASSESSMENT OF THE RECONNECTION AND REHABILITATION OF THE BUOTA – TANAEA WATER SUPPLY, TARAWA

**GOVERNMENT OF KIRIBATI – KIRIBATI ADAPTATION
PROJECT IMPLEMENTATION PHASE (KAP II)**

MAY 2010

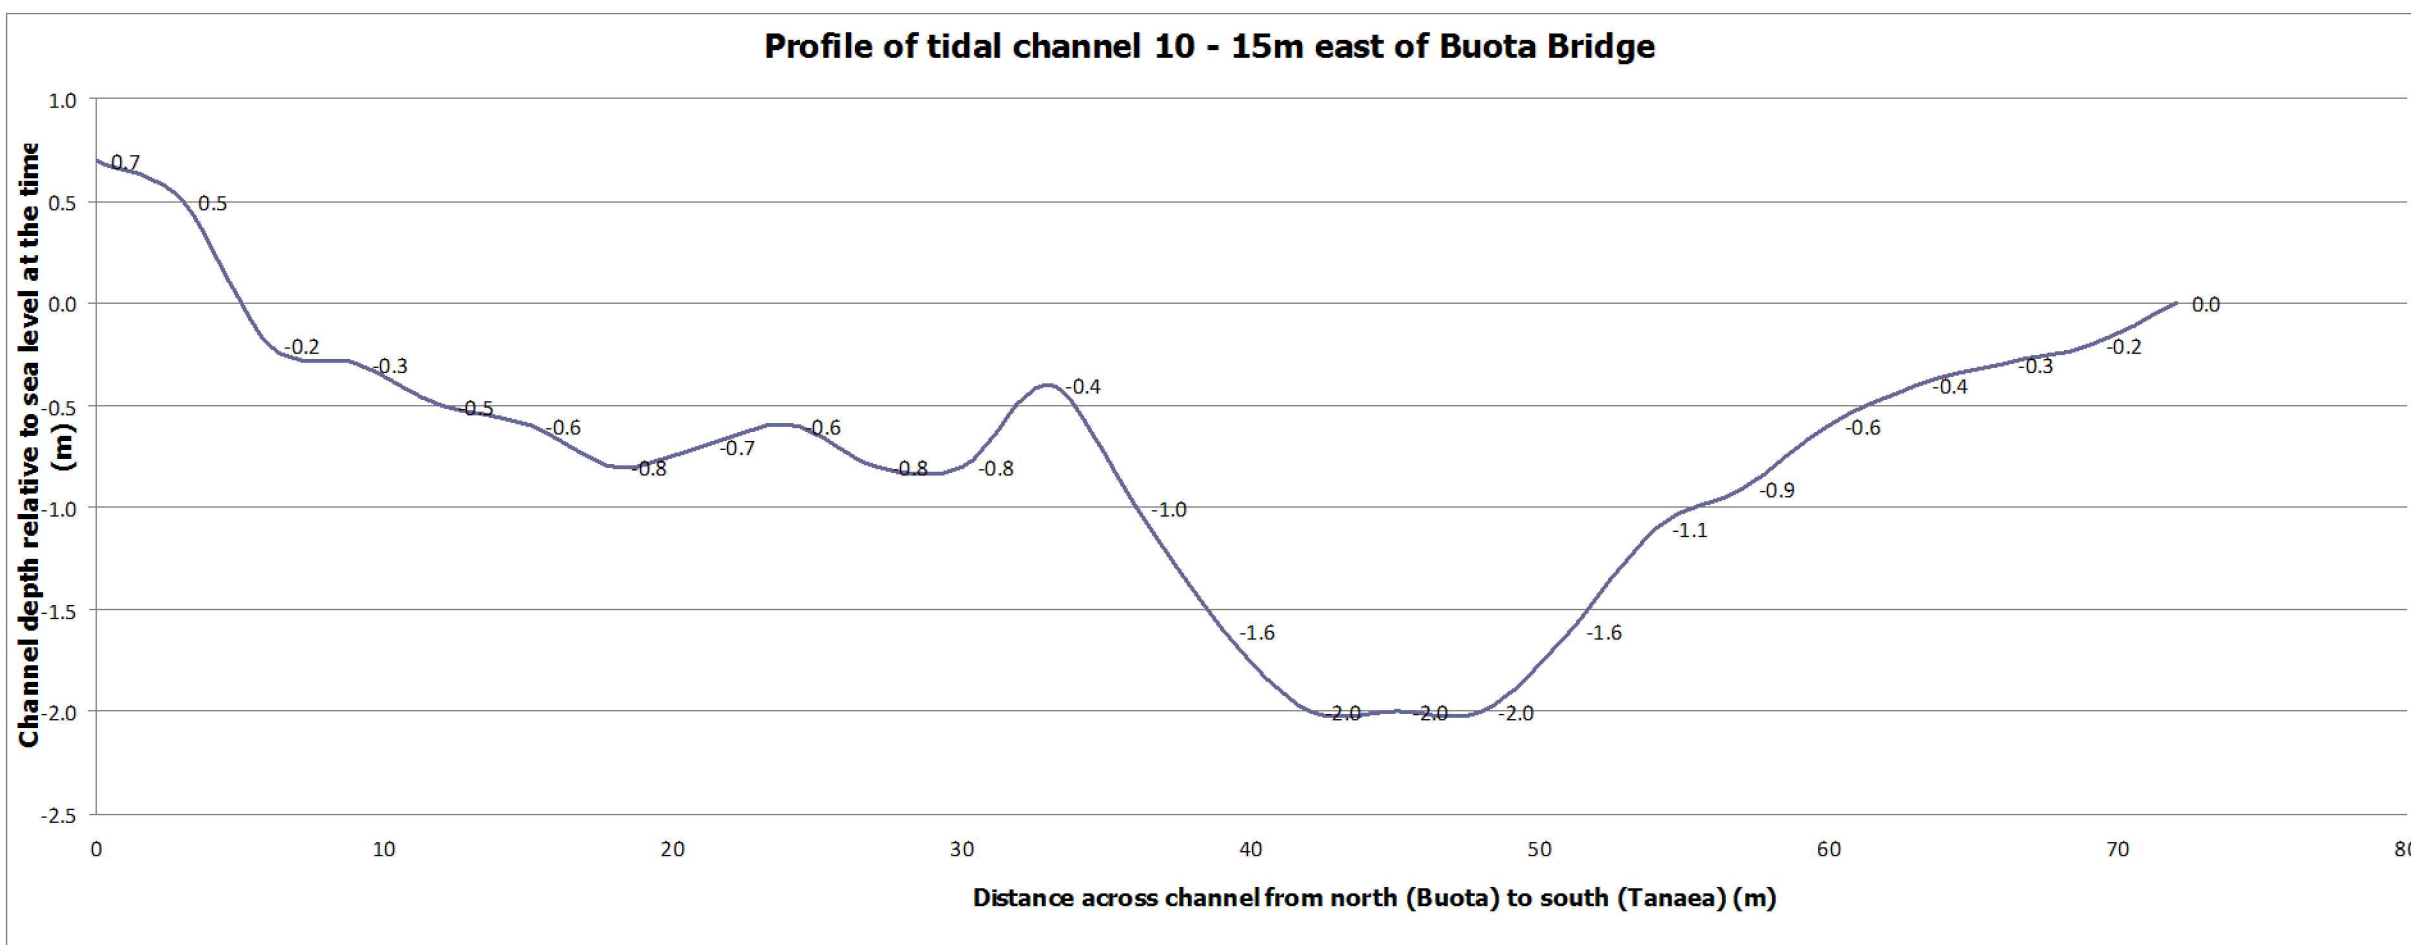
Profile of tidal channel 10 - 15m east of Buota Bridge

A possible line for the pipeline would be to run c. 3-5m to the east of the bridge access ramps, c. 10m East of the Buota Bridge. In order to assess the practicalities of the route across the channel, data to form a channel profile was gathered. This data was collected by wading and swimming across the channel and recording the depth of the channel relative to the sea level at that time. The survey was carried out at 08:15 – 08:30 on Saturday 8th May 2010.

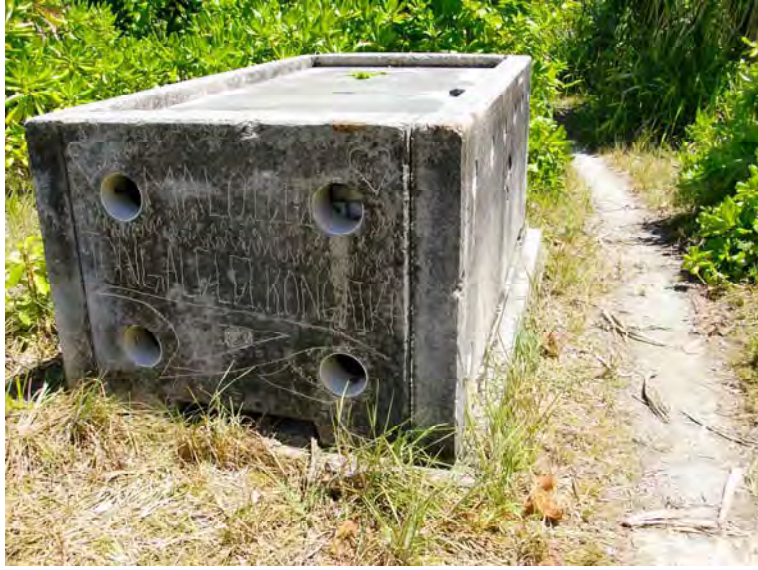
Each concrete panel has a number of holes, possibly ventilation holes, formed using PVC pipe and have an additional horizontal slot at the base. The end panels contain 4 x 160mm holes which are used to locate the bolts from the adjacent side panel and a 0.55m x 0.1m horizontal slot at the base. The side panels contain 8No. 100mm holes and a

2.06m x 0.1m horizontal slot at the base. These holes/vents enable people to damage the internal components with sticks, bars and provide access for hands and tools to undo the bolts of the hasp that retains the pump chamber galvanised steel covers. Once the covers are released, all of the internal components are stolen.

| Pump Chamber | Condition | Parts to be replaced | Depth of water within gallery chamber | Depth from surface to base of sump |
|---|---|---|---|---|
| 3 | 1 good bolt on concrete panels, 3 rusty and 4 missing. The internal components are <i>in situ</i> . | Pump, electric motor, flow meter, non-return valve, gate valve, sampling gate valve. Refurbishment of electric control panel required. | 2.02m | 3.2m |

Photo No. 1 - Pump chamber No. 3 showing the large ventilation holes on the end panel.

It is recommended that 16No. 5mm galvanised flat u-shaped steel plates are fabricated and bolted to the inside of each chamber to prevent hand/stick access into the chamber whilst retaining ventilation. The plates could be fixed using short M10 bolts grouted into inner chamber wall, secured with a split washer and nut to suit. Similar plates should be fabricated and fitted to restrict access to the inside of the pump chamber through the slot at the base of the concrete side panels.

Once the missing or rusty fixing bolts have been replaced the bolts should be cut flush with the concrete and grouted in place to prevent future tampering or corrosion. Once the bolts have been fixed the holes within the end panels should be filled with concrete to prevent future access to the bolts and to the components within the pump chamber. Ventilation will be maintained through the horizontal slots along the base of each panel and through the holes within the side panels.

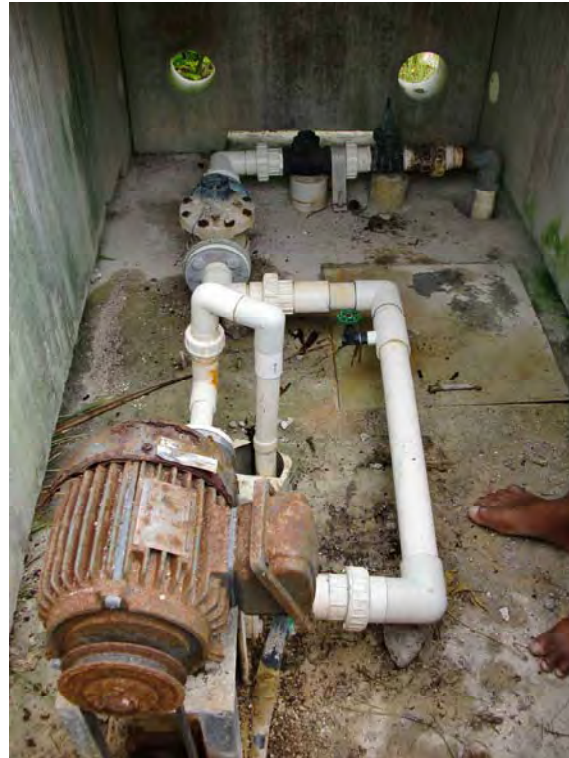
Photo No. 2 - Inside pump chamber No. 3 with complete pipework and fittings but requires refurbishment.

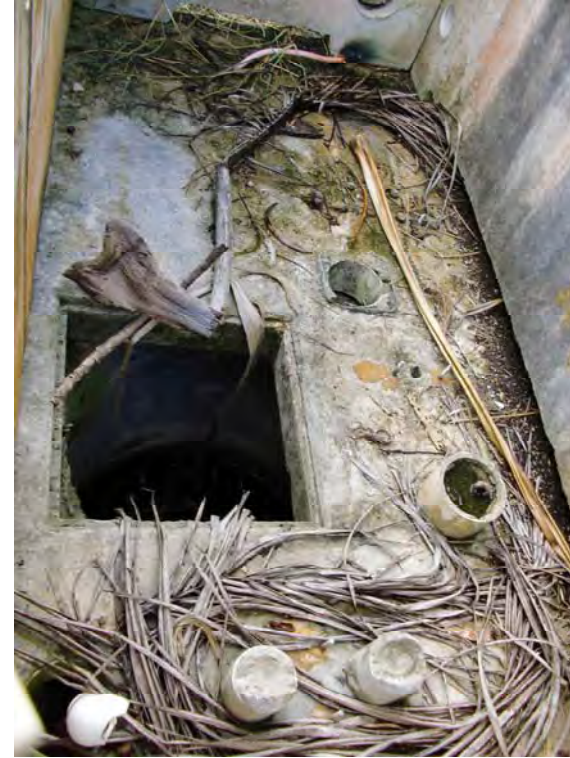
Photo No. 3 - Pump chamber No. 5 with all components stolen and vegetation has fallen into the well.

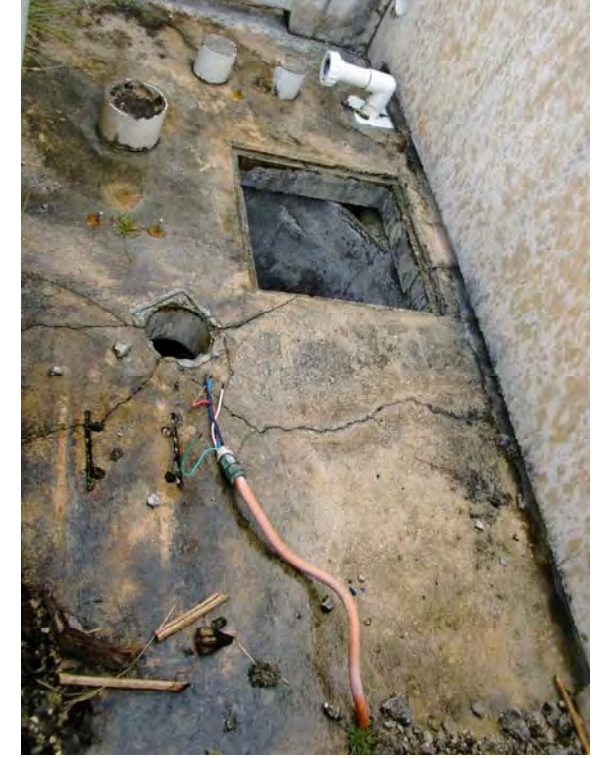
Photo No. 4 - Pump chamber No. 4 with all components stolen.

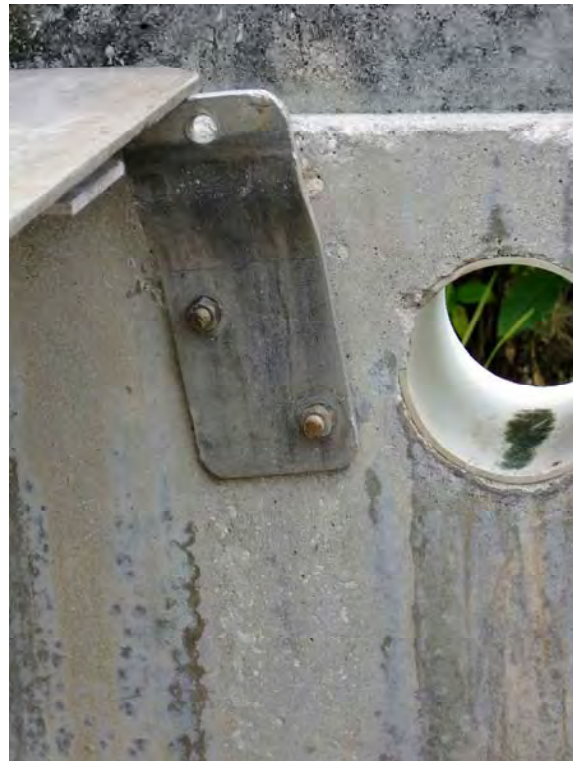
Photo No. 5 - Photo showing ease of access through chamber ventilation holes enabling the hasp bolts to be released.

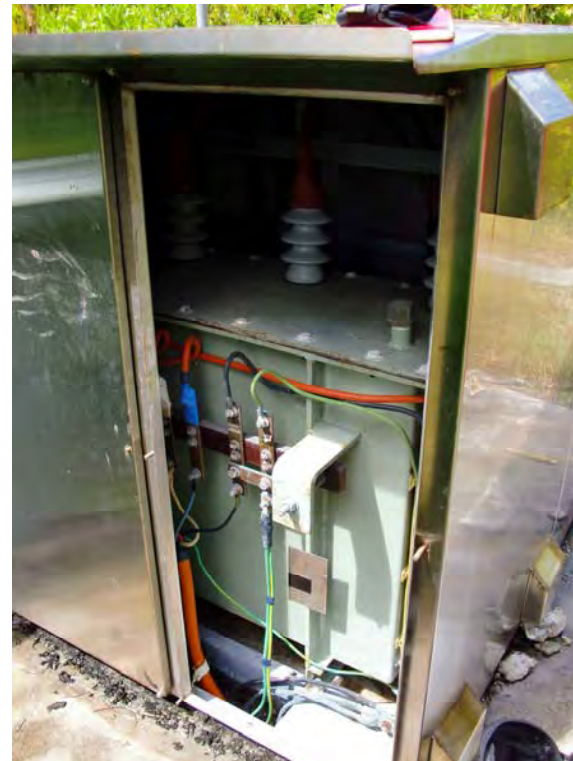
The main 11Kv transformer is housed within a stainless steel 4 door cabinet, whilst the switchbox is located directly onto the concrete and not housed in a cabinet. One of the doors to the 11Kv transformer has been removed, leaving the live transformer connections exposed to the public. The PUB Electricity Department has been informed that one of the cabinet doors is missing and it has been recommend that the panel is replaced urgently.

If the power to the transformer is switched off, rather than the missing panel replaced it is suspected that the whole transformer will be stolen.

Photo No. 6 - Missing panel enabling easy access to live 11,000 volt connections.

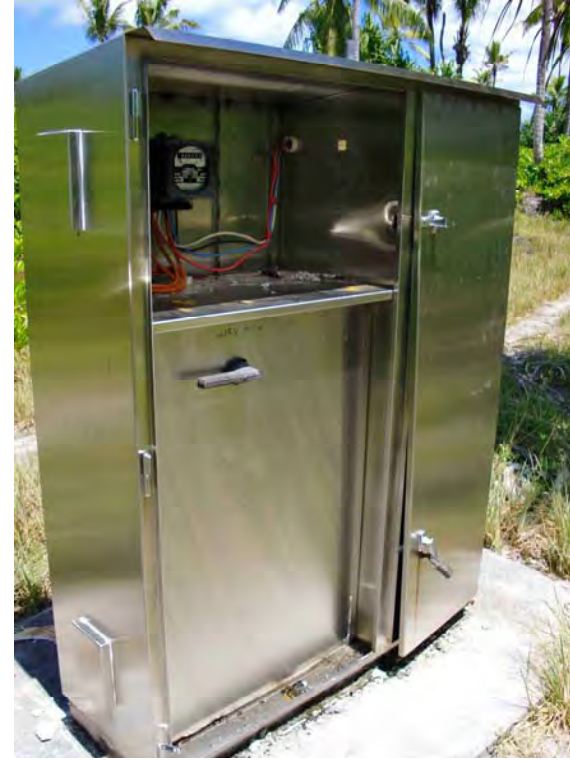
Located close to pump chamber 3, the main control box is contained within a 2 door stainless steel cabinet. One door has been removed providing unlimited access to the meter (vandalised) and the 3 phase master switch, whilst the lock for the other door has been broken and many of the electrical components have been removed. The 2-3mm stainless steel cabinets have proved to be very resistant to the natural elements, having been installed 10 years ago but have no been so successful at resisting the human element.

Photo No. 7 - Photo showing missing and broken door on main control unit.

It is recommended that the main control box and sub-main control boxes are rewired and the cabinet doors are replaced however additional security devices should be used to secure the doors to prevent unauthorised access in the future. Additional security devices may comprise the fitting of McGard's Intimidator locking bolts (or similar) at the corner of each door.

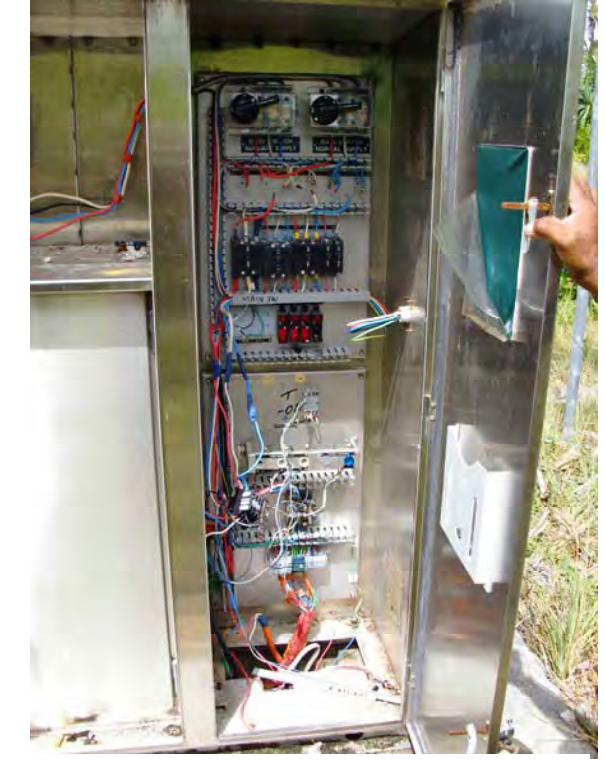
Photo No. 8 - Photo showing the vandalised electric panel due to a broken door lock on the main control unit.

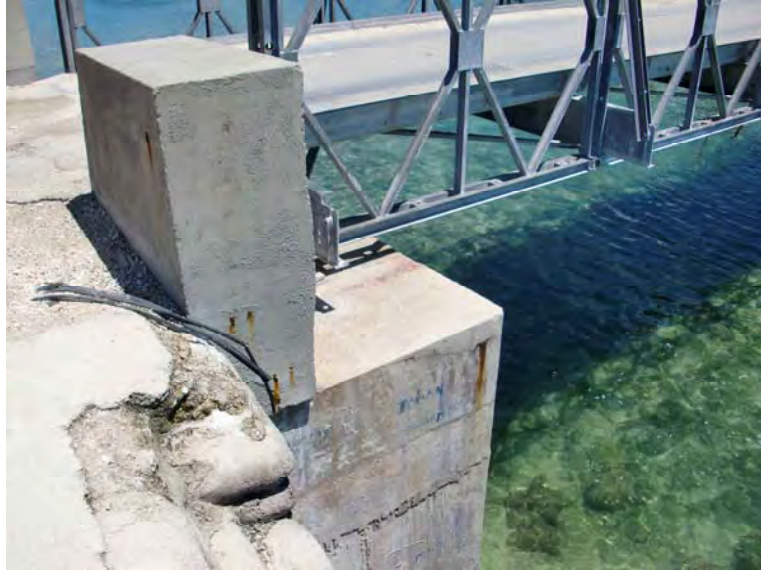
Photo No. 9 - Southern guard block which needs to be cored through or the pipe routes around. If routed around the concrete sand bags will require reinstating.

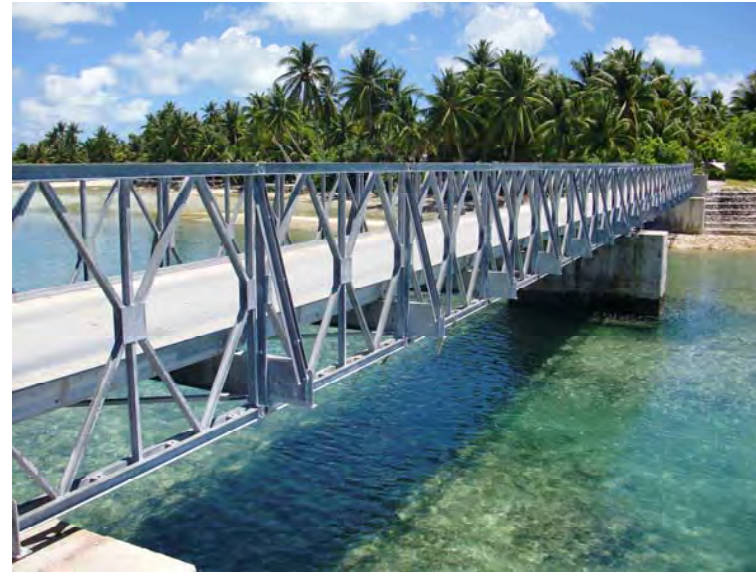
Photo No. 10 - The lower side rail is the recommended route from which the pipeline could be suspended.

It is recommended that the pipeline is routed across bridge suspended beneath the lower side beam of the bridge, using galvanised steel hanging brackets. The option of threading

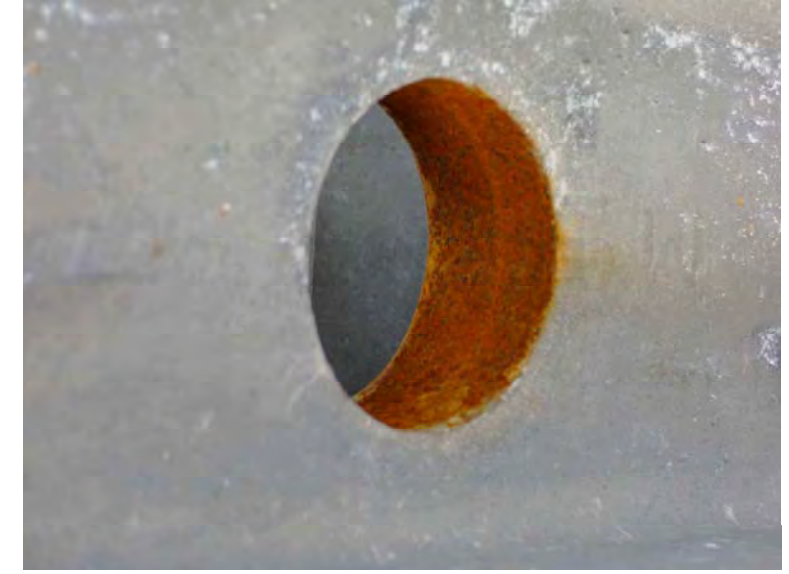
Photo No. 11 - Rust discolouration already showing in most of the holes in the upper and lower cross rails of the Mabey bridge.

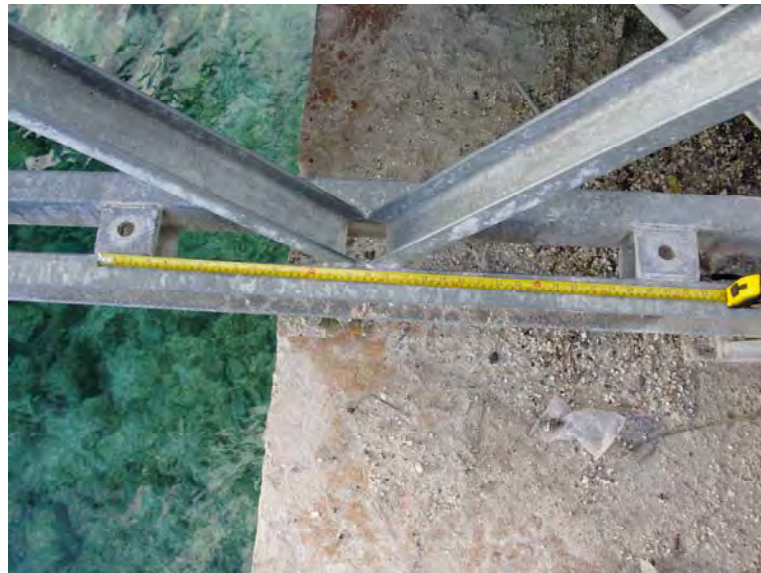
Photo No. 12 - The lower side rail is the recommended route from which the pipeline could be suspended.

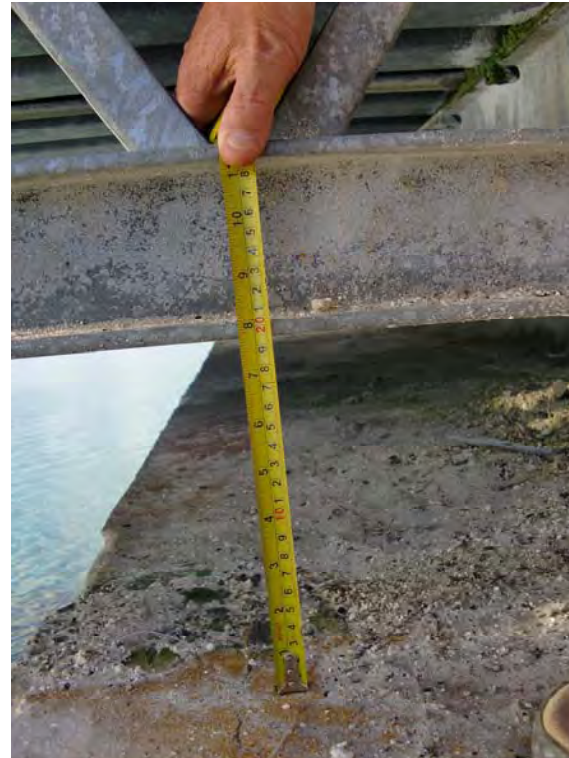
Photo No. 13 - The 200mm clearance between the lower rail and the bridge abutment.

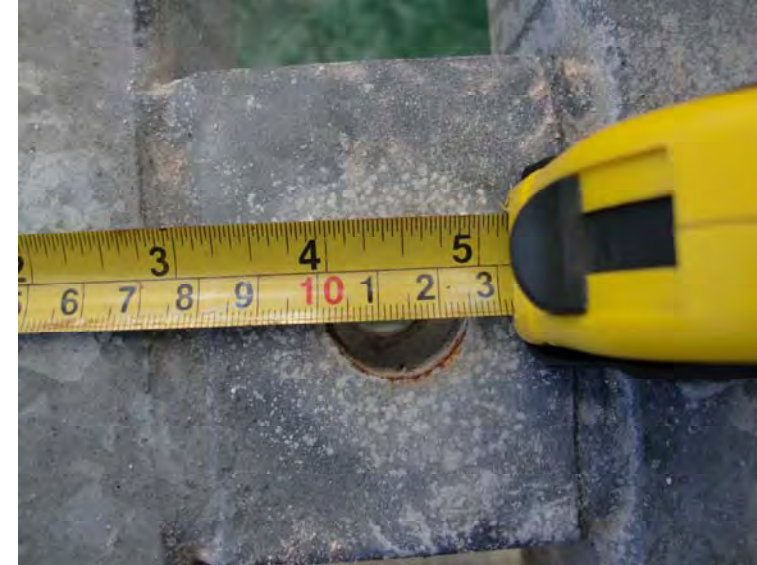
Photo No. 14 - The 25mm diameter pre-dilled hole in the lower side rail. Note the rust discolouration forming after just 6 - 9 months.

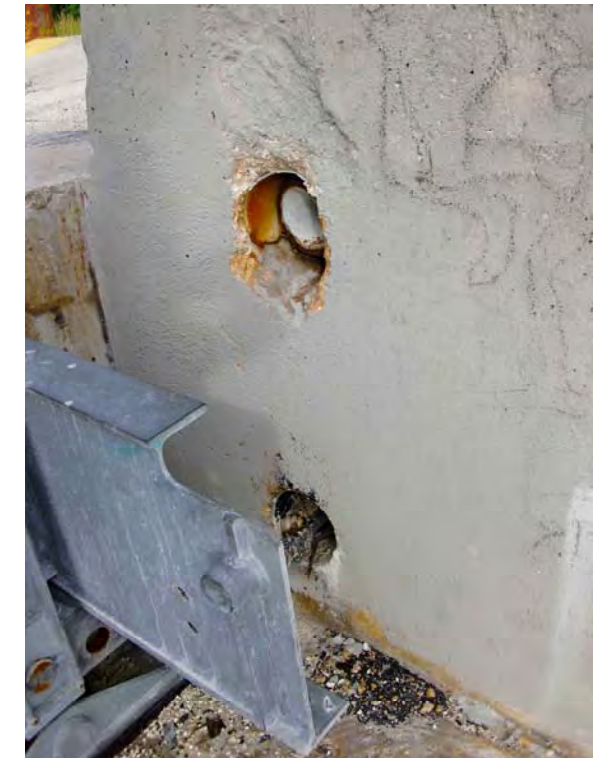
To use the upper duct through the guard block on the northern end of the bridge as previously, the water pipe must be located at ground surface level immediately before entering the guard block, exposing the pipe to UV and damage. It would be greatly beneficial if the pipe were to use the lower duct thus enabling the pipeline to remain c. 500mm below ground level.

Photo No. 15 - The northern guard block showing the old water pipe in the upper duct and the electric cable in the lower.
