## Preparation of Water Master Plan for Tarawa

KAPII Component 3, Freshwater Resources. Project 3.2.1

# Report on the Protection and Management of Water Reserves, South Tarawa

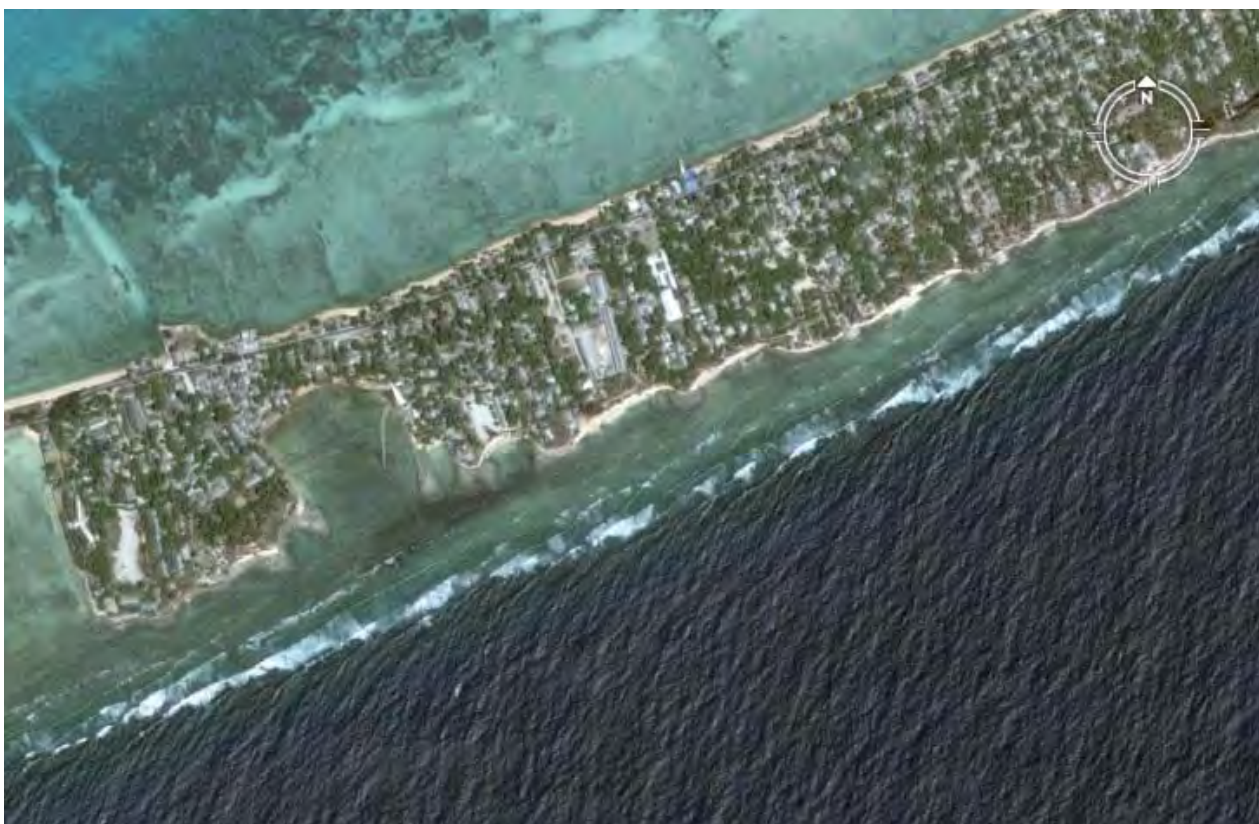
**Figure 1. Teoraereke, South Tarawa. The water reserve here was abandoned due to encroached by settlers (Google Earth).**

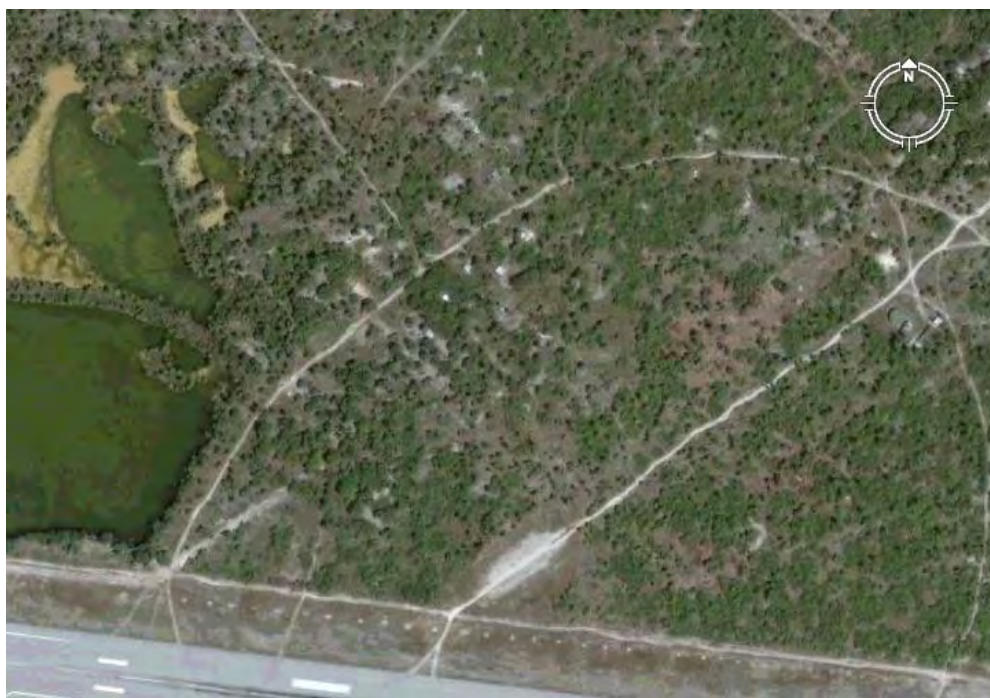
Salinity of the pumped groundwater at Bonriki and Buota is monitored routinely by PUB staff located at the chlorination plant in Bonriki by monitoring the electrical conductivity, EC, of the pumped water<sup>17</sup>. This monitoring takes the form of daily measurements of the salinity of the combined outputs from all gallery pump stations in Bonriki and Buota water reserves prior to chlorination as well as periodic measurements of the EC of individual pumping stations on both water reserves. Measurements at individual pumps are necessary because of the spatial variation of salinity in across the islands. In Bonriki, salinity is generally higher towards the western end of the island close to the two large ponds (Figure 4).

**Figure 4. Salinity of pumped groundwater at Bonriki is highest near these ponds at the western end of the island (Google Earth).**

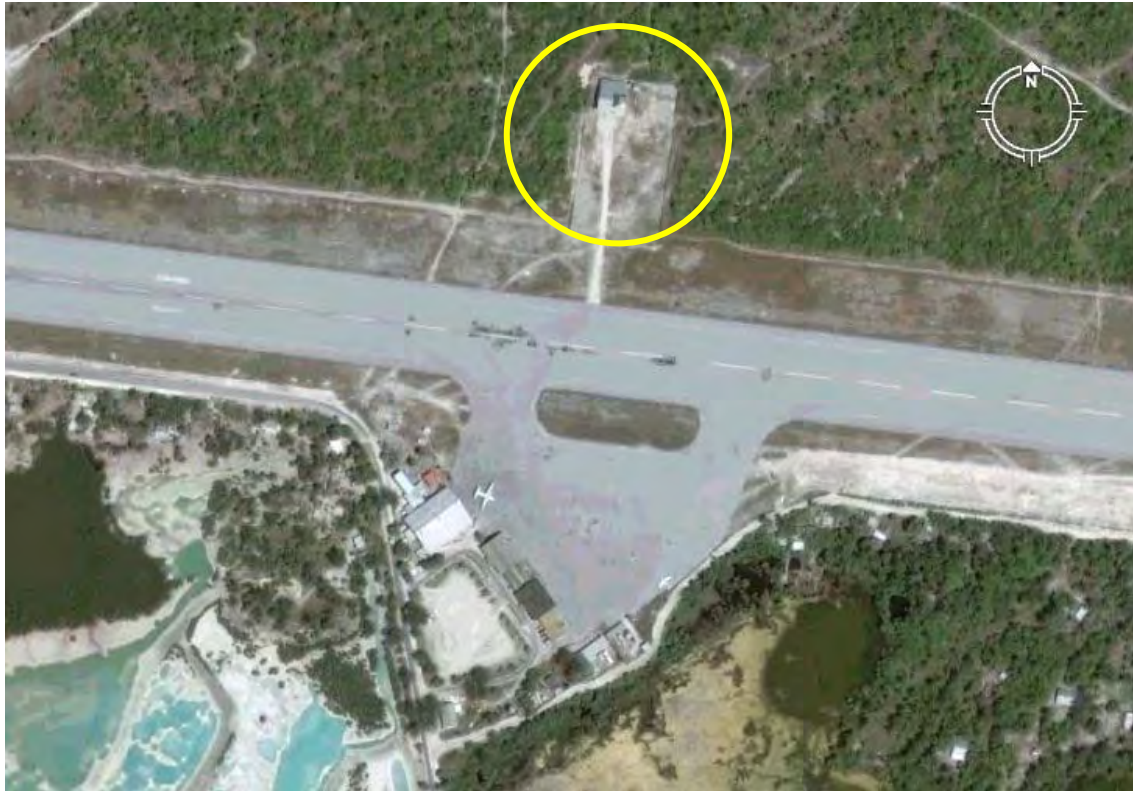
The Bonriki Airport control tower, constructed under an EU project in 2004, was cited on the northern edge of the airport runway within the Bonriki water reserve (Figure 7) because of line of site requirements and space availability. A government steering committee for the project included the lead water and environment ministries who approved the plans despite it clearly contravening the water reserve regulations and public health bye-laws. To make matters even worse, the septic tank toilet for the control tower is located directly over one of the two infiltration gallery arms leading to Bonriki pump station, PS 7 as shown in Figure 8.

**Figure 7. The Bonriki International Airport Control Tower (circled) located on the water reserve (Google Earth)**

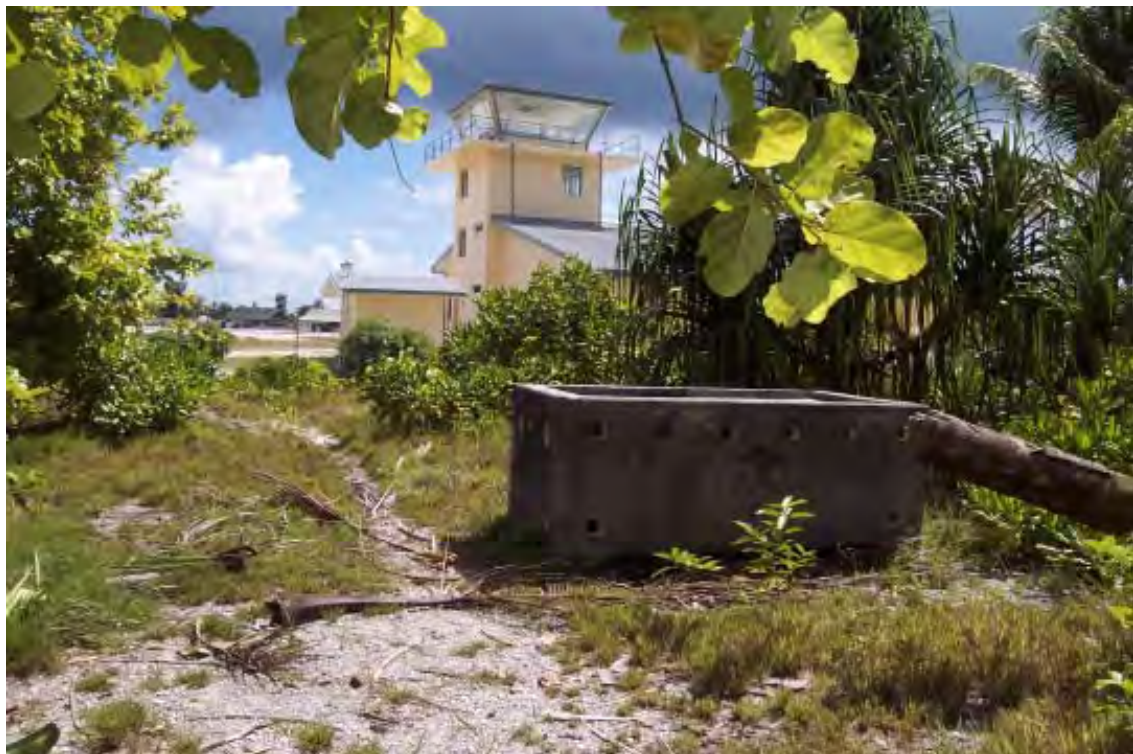
**Figure 8. The septic tank toilet for the Control Tower is located over one of the infiltration gallery arms leading to Bonriki pump station 7 in the foreground right**

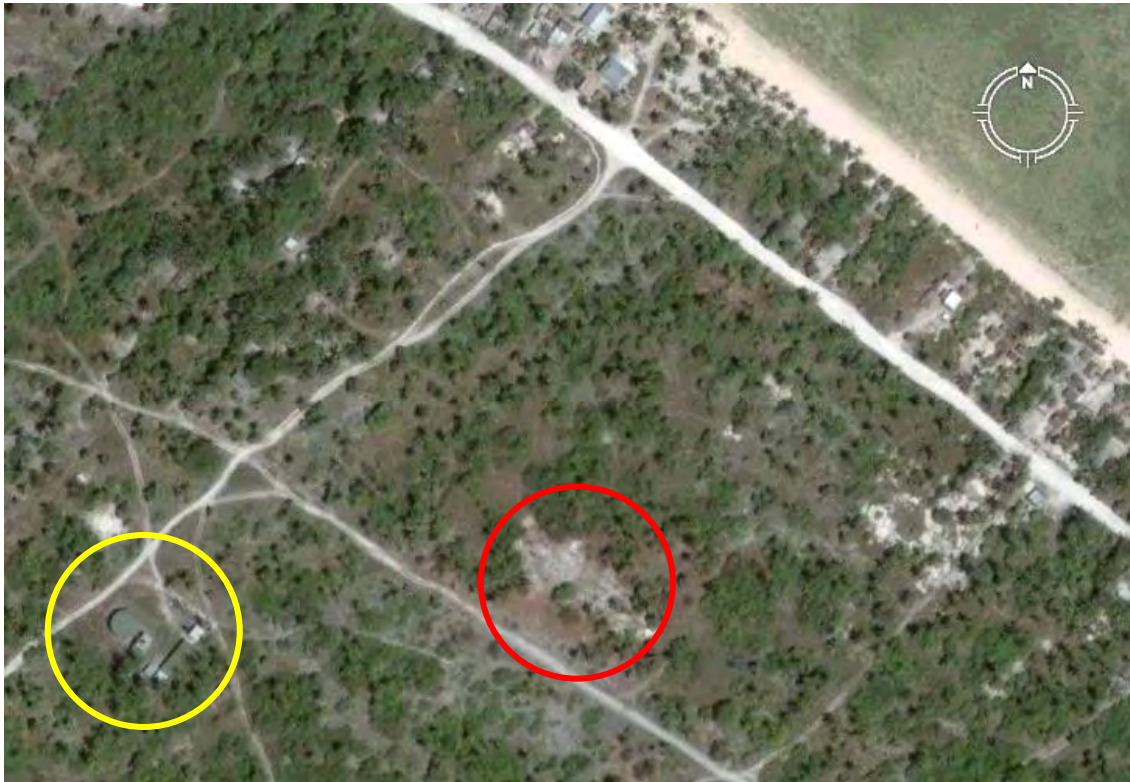
At the time, the suggestion to allow settlement in a 50 m buffer strip along the ocean-side perimeter of water reserves (Falkland, 1992), seemed a just and equitable solution to *baki-aba*. At Bonriki, however, this settlement has accelerated encroachment on the water reserve (Figure 9). Some of the houses on the water reserve are substantial (Figure 10).

**Figure 9. Encroachment of houses onto the Bonriki water reserve across the 50 m boundary road in the northeast. The Bonriki water treatment and pumping plant near the centre of the reserve is circled in yellow and an active cemetery is circled in red (Google Earth).**

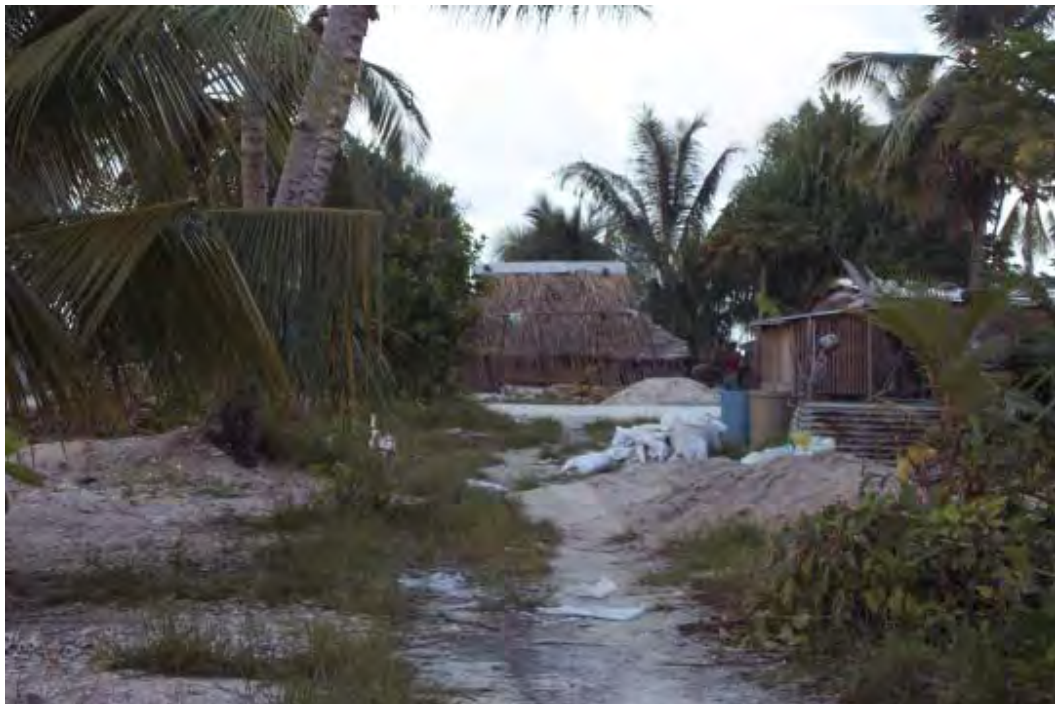
**Figure 10. A typical house erected illegally on the Bonriki water reserve.**

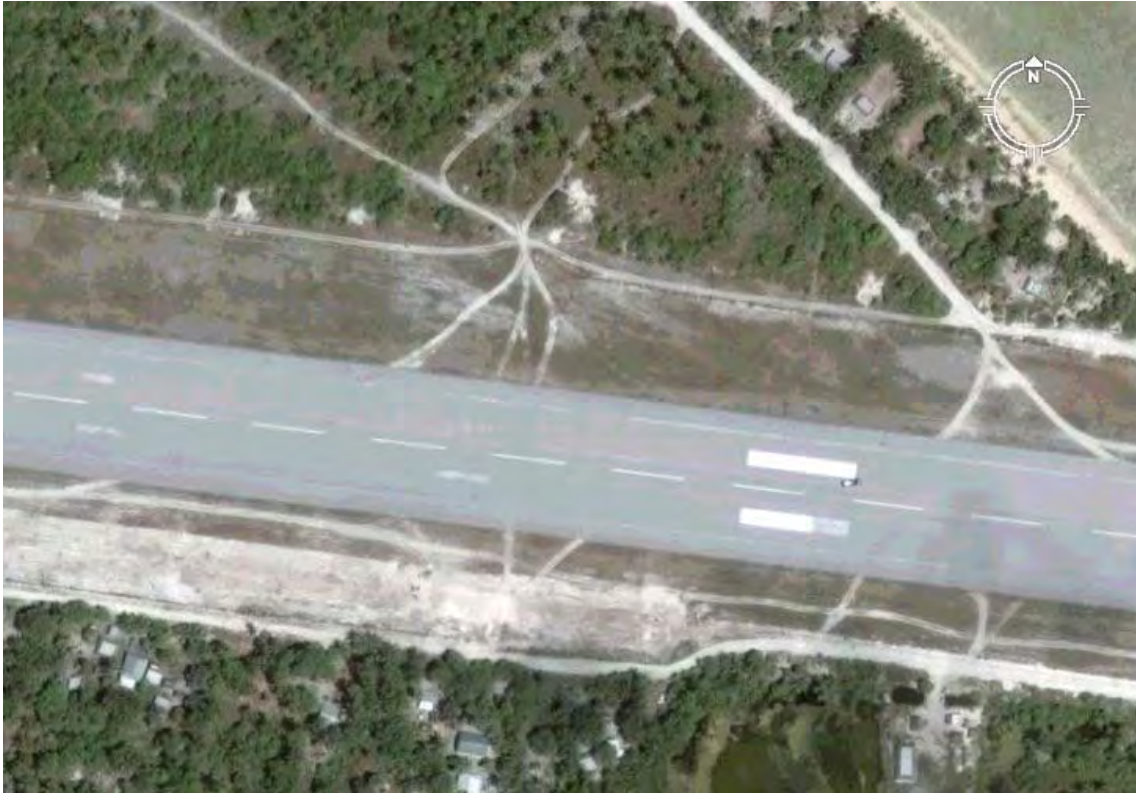
On repeated inspections of the reserve, the impacts of mining have been found to progressively worsen and constitute a significant threat to South Tarawa’s reticulated water supply.

**Figure 11. Sand and gravel mining within the Bonriki water reserve and close to gallery pump station PS1. The boundary road is again on the northeast ocean side (Google Earth).**

10. Ensure that all groundwater pumps are operating at the design sustainable rate
11. Fill in all domestic water wells, babwai pits and sand and gravel pits on the water reserves

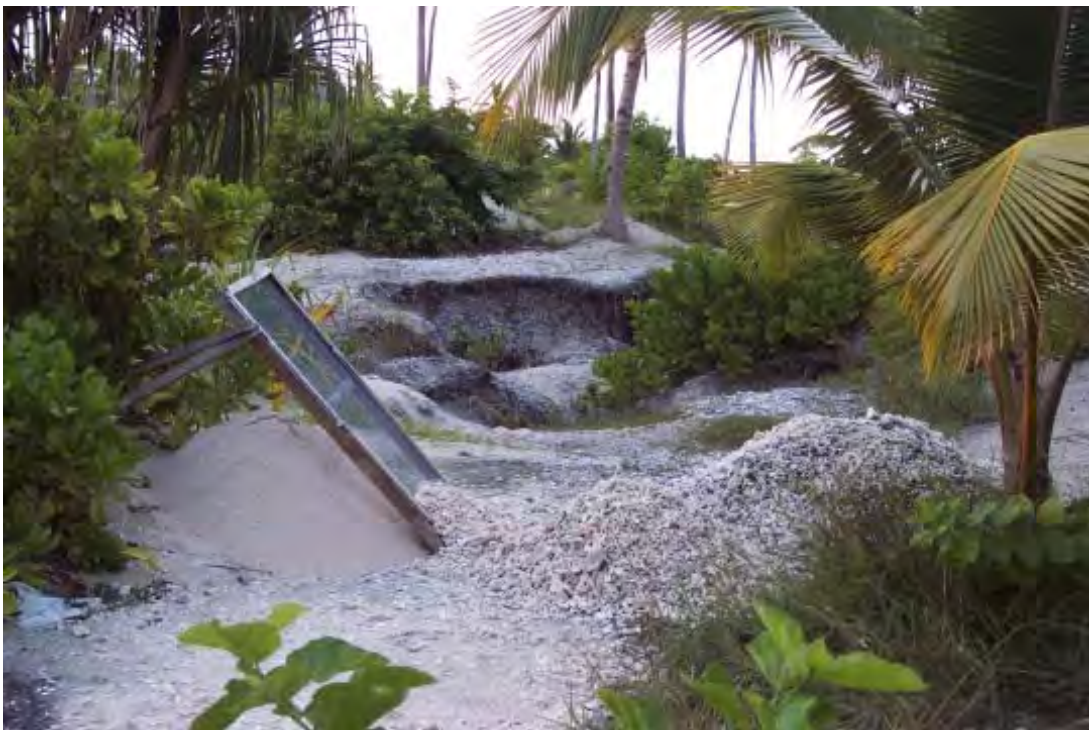
**Figure 12. Sand and gravel mining on the Bonriki reserve. Note the undercutting of coconut trees which eventually leads to death of the tree.**

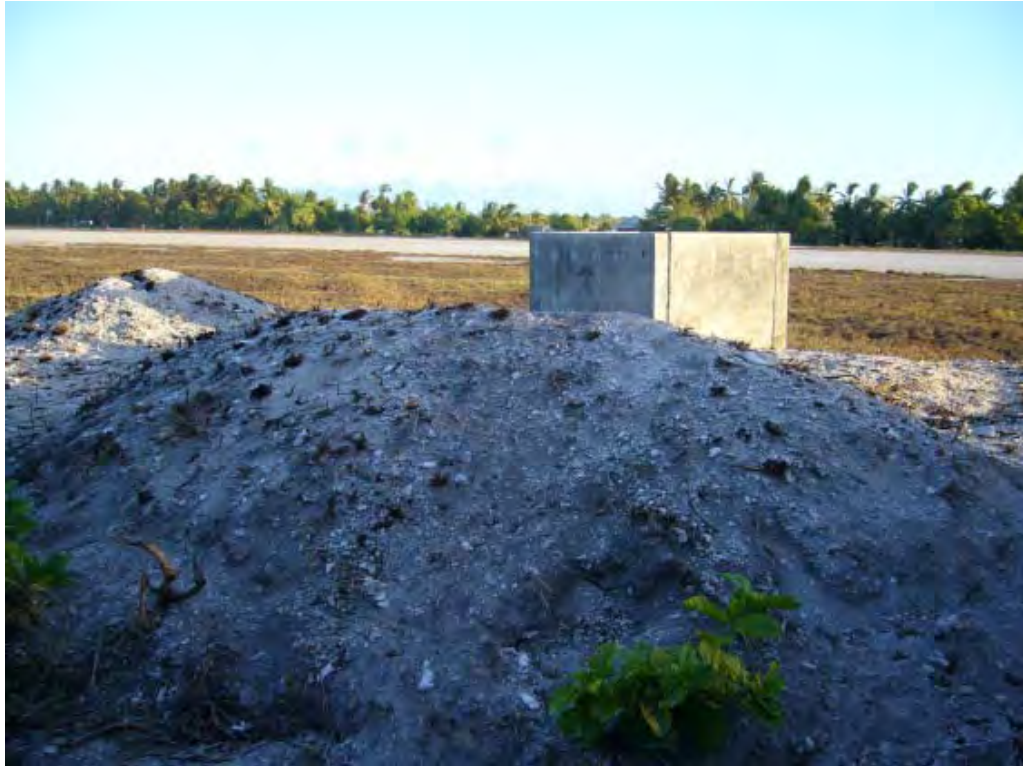
**Figure 13. Gravel mining beside Bonriki gallery pumping station PS1 on the eastern end of the reserve.**

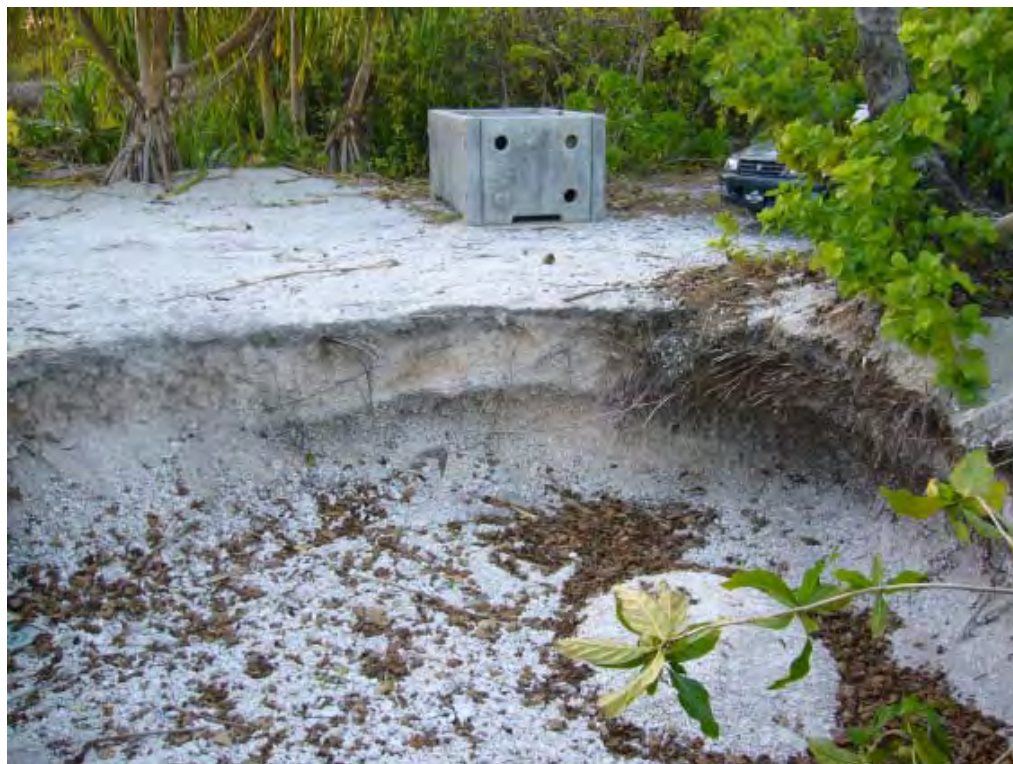
**Figure 14. Sand and gravel mining has completely destroyed salinity monitoring borehole BN 16 (beside PS 7), one of the oldest and the deepest borehole in Bonriki.**

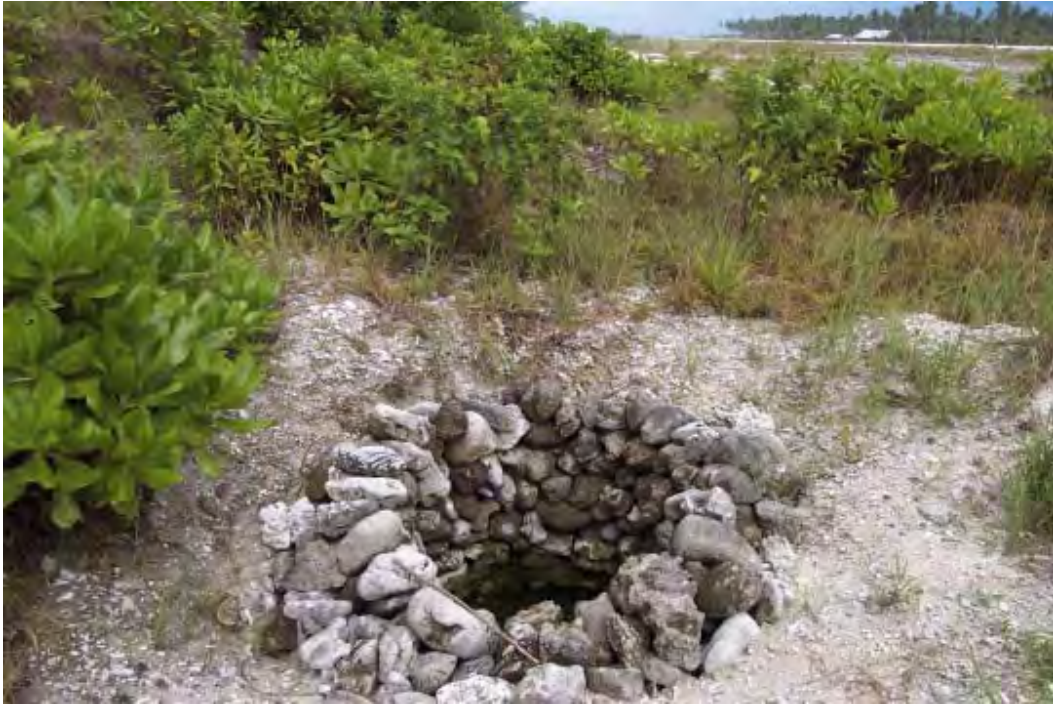
**Figure 15. Open well dug down to the groundwater near PS 1. This has algal blooms growing on the water surface.**

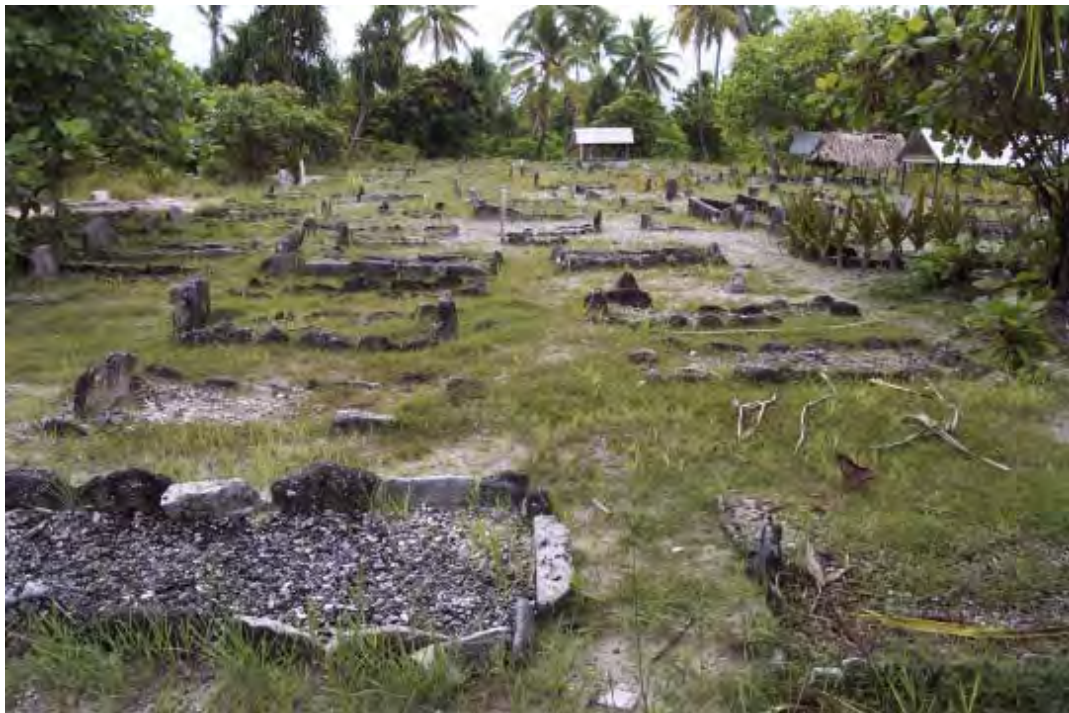
**Figure 16. Active graveyard on the Bonriki water reserve close to the centre of the reserve and between PS 6 and PS 8.**

8. Introduce school curricula on the protection and care of public water sources
9. Provide alternate venues for burials so that the cemeteries on water reserves are no longer used.

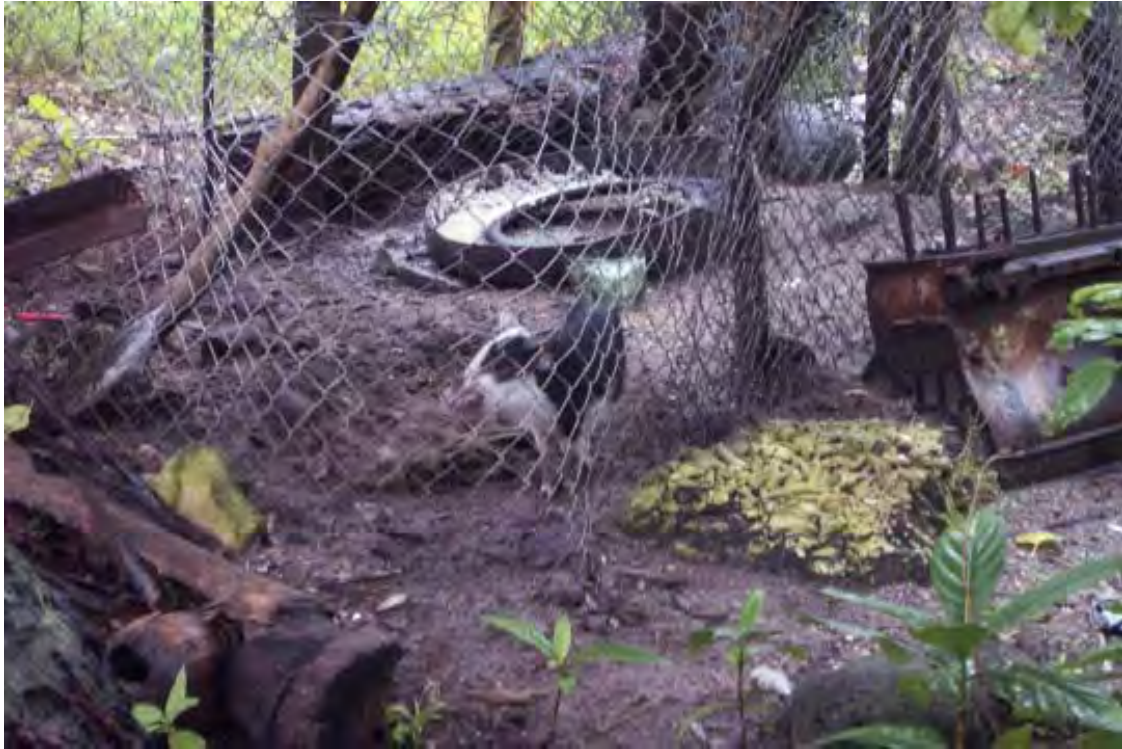
**Figure 17. Raising of pigs on the Bonriki water reserve between PS 14 and PS 15.**

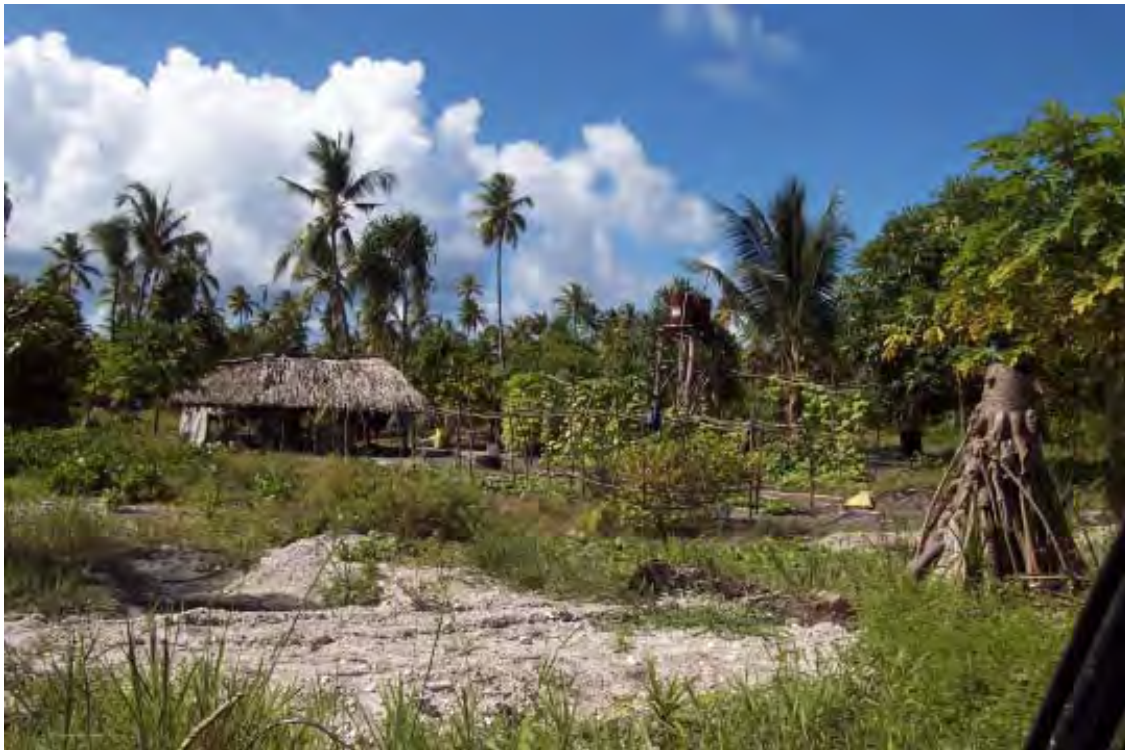
**Figure 18. Growing vegetable crops on the Bonriki water reserve near PS 13.**

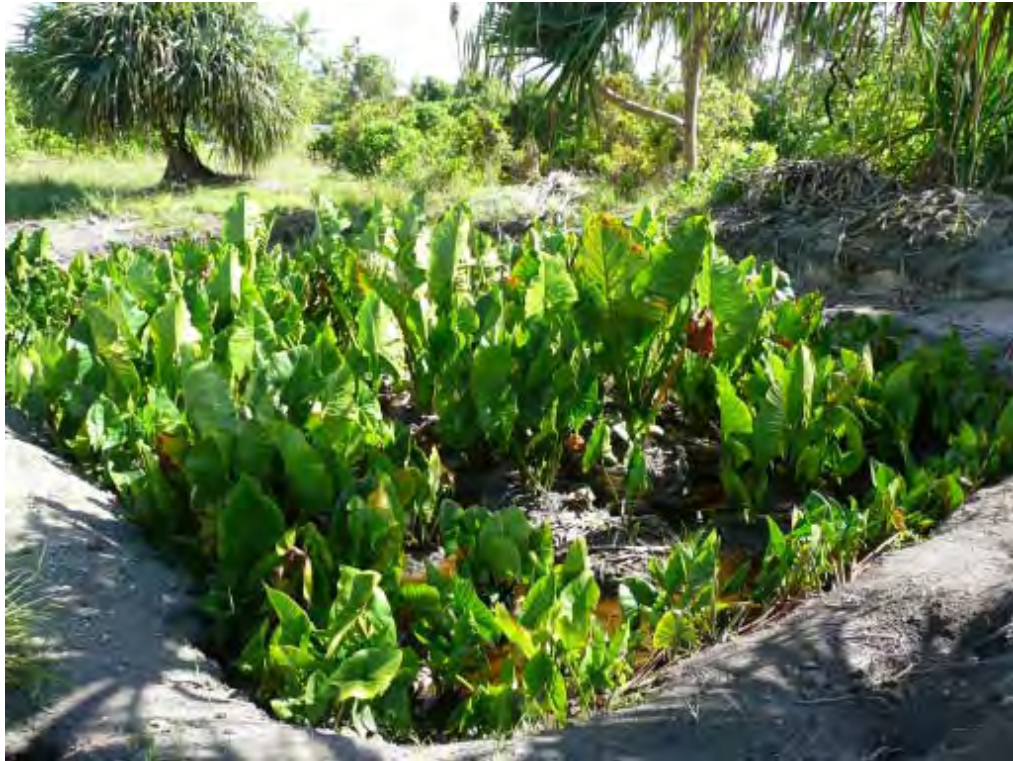
**Figure 19. Babwai (swamp taro) growing on the western side of the Bonriki water reserve. It is grown and fertilised directly in the groundwater.**

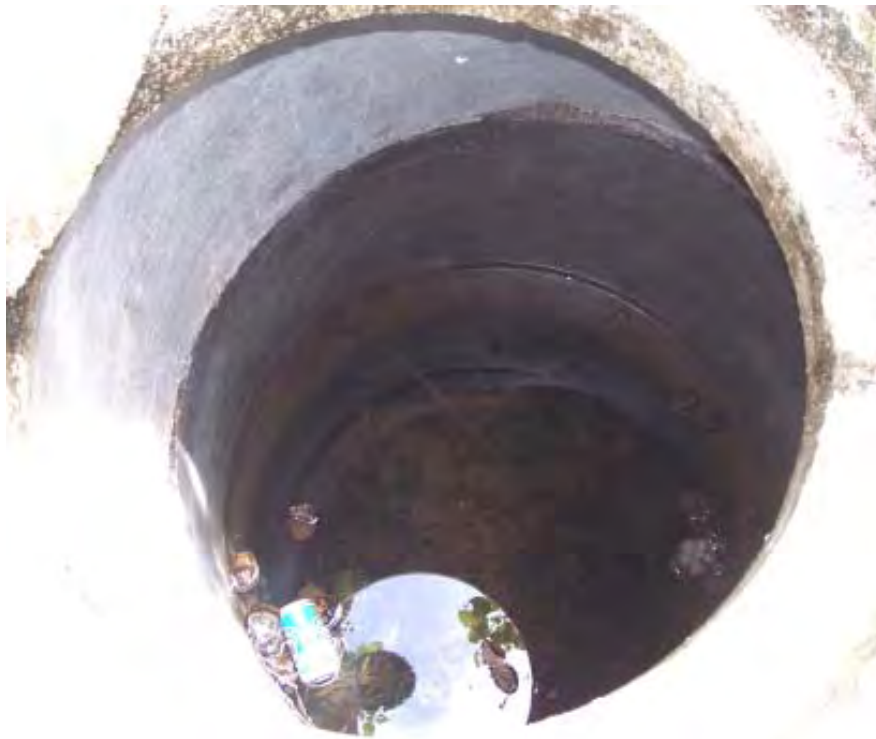
- Direct pollution (Figure 20). The terminal wells of gallery pump stations can be opened and these have been used as rubbish dumps and as toilets. The risk to Tarawa’s water supply from this is immense.

**Figure 20. Rubbish thrown down the terminal well of PS 7.**

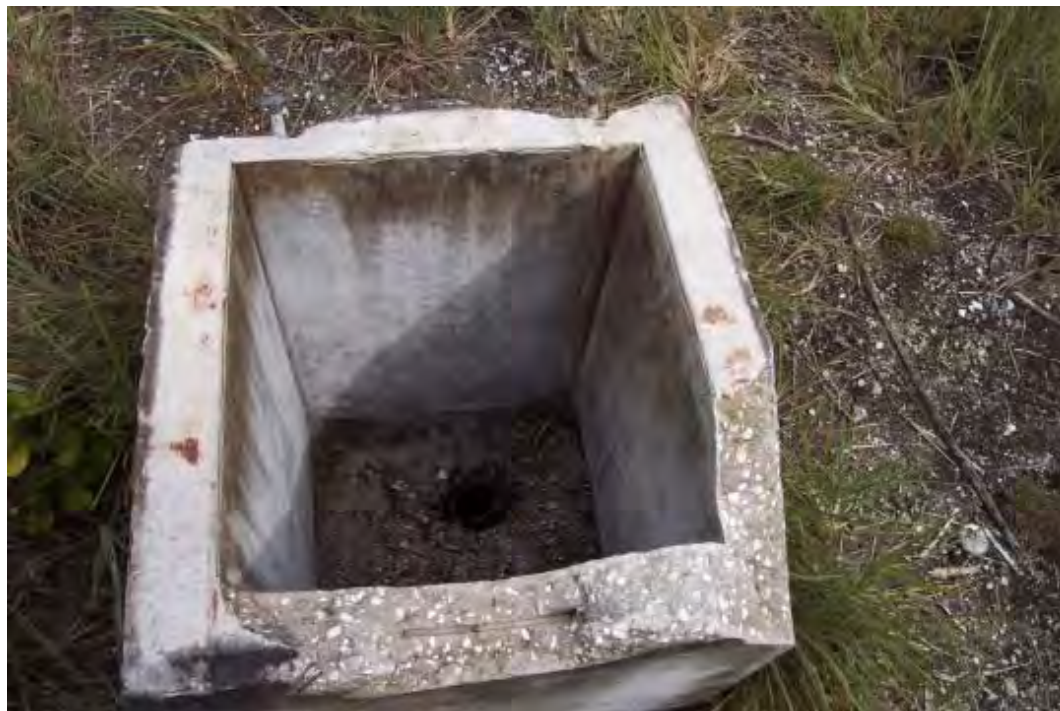
- Vandalism of infrastructure (Figure 21). Vandalism is a continuing problem in the water reserves. Pumps have been burnt and salinity monitoring boreholes, essential for tracking the impacts of pumping are regularly destroyed. This points to significant problems in the management of the water reserves.

**Figure 21. Vandalism to infrastructure is a reoccurring problem in water reserves. This was Bonriki salinity monitoring borehole BN4B. The steel lid has been smashed off and the piezometer tube and salinity monitoring tubes have all been removed.**
