KAP – II – FS6 Improving the Protection of Public Assets

# Coastal Monitoring Benchmark Network

**Prepared for the Office of Te Beretitenti, Government of Kiribati (Client)**

14 February 2011

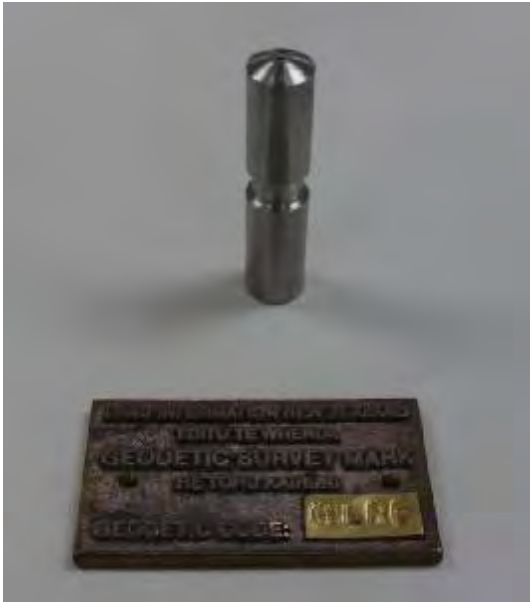
Stainless Steel pin (25mm dia)

Bronze ID plaque. Note: lettering would be changed for Kiribati project to:

**GEODETIC BENCHMARK**

**BM NO:**

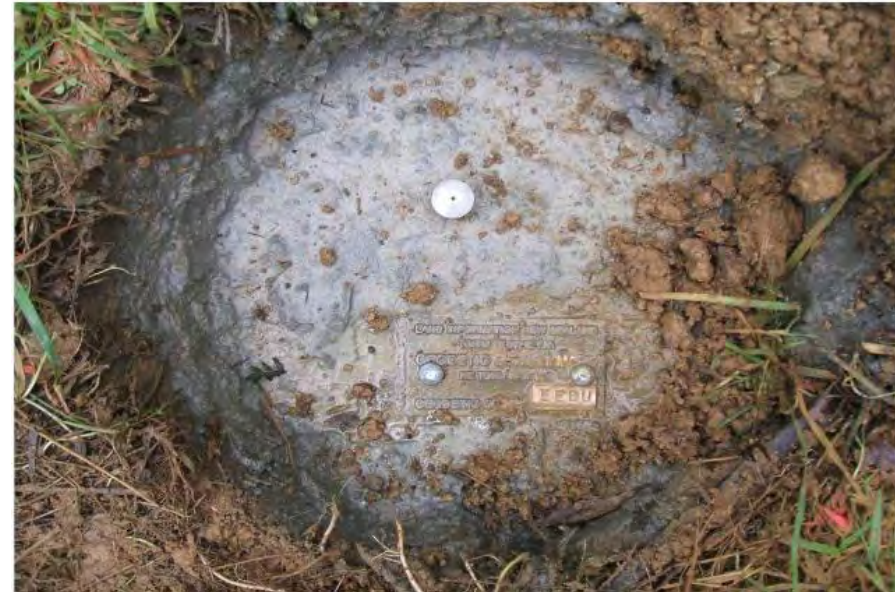
Geodetic Benchmark example construction showing the stainless steel pin and identification plaque

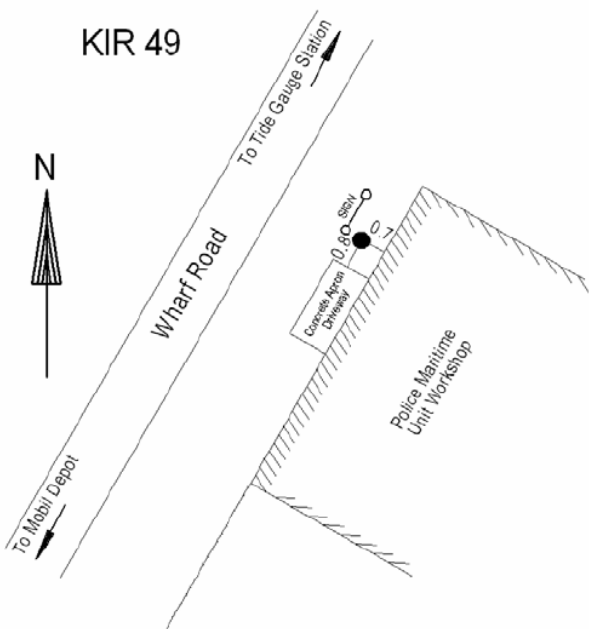
**Bench Mark Number: KIR49**

<p><i>Original Bench Mark Established by:</i> National Tidal Centre Australia, Oceanographic Services, Bureau of Meteorology, 25 College Rd, Kent Town, SA.</p>	<p><i>Date:</i> 07-06-02</p>
<p><i>Existing Bench Mark Established by:</i></p>	<p><i>Date:</i></p>
<p><i>Notes / References:</i> Deep Survey Benchmark This survey mark is not in a good locality for GPS occupation.</p>	
<p><i>Country:</i> Kiribati <i>Island:</i> Tarawa</p>	<p><i>Atoll:</i> Betio</p>
<p style="text-align: center;"><u>Marking and locality sketch</u></p> <p>Bench Mark: 2.5m of 19mm diameter stainless steel capped rod driven to refusal. Rod sheathed with 50mm diameter PVC pipe, filled with bentonite, for 0.5m. Top of mark 0.1m below ground level.</p> <p>Locality sketch: Mark approximately 200m from the tide gauge station.</p>

<p>The sketch shows a north-south oriented road labeled 'Wharf Road'. At the top of the road is an arrow pointing north labeled 'To Tide Gauge Station'. At the bottom of the road is an arrow pointing south labeled 'To Mobil Depot'. To the east of the road, there is a building labeled 'Police Maritime Unit Workshop'. A survey mark is indicated by a black dot on the road, with a label 'KIR 49' above it. A scale bar below the sketch shows '0.80' and '0.10' in metres.</p> <p>Not to scale                      Distances in Metres                      Magnetic bearings</p>

When locating the Deep driven Bench Marks prior to the survey it was found that BM KIR49 (located outside the Police Marine Workshop) had been buried under an extension of the concrete driveway and not accessible. With the assistance of the Marine Police, a 300mm diameter hole was chiselled away to expose the BM below the concrete and a valve box with lid cemented in place. All other deep driven bench marks were located and found undisturbed and in good order.
